Report No: JC000207

| Client | Harvest Operations Corporation | Inspection Date | Feb 24, 2009 | | |
| Equipment Type | Contactora | Location | Tweedie | | |
| Serial Number | 94033-AA | Year Built | 1994 | | |

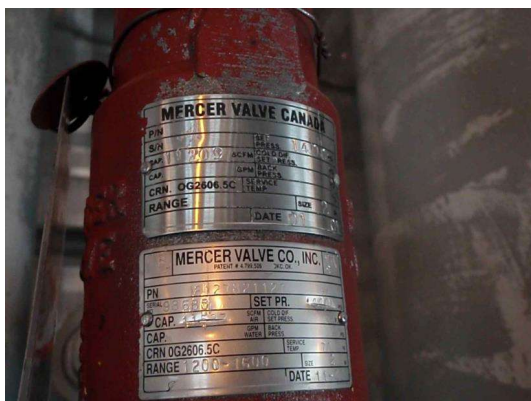
Figure: 1

PSV nameplate General Overview

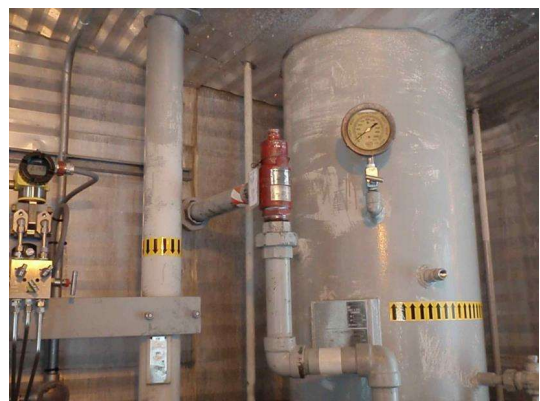
Figure: 2

PSV General Overview

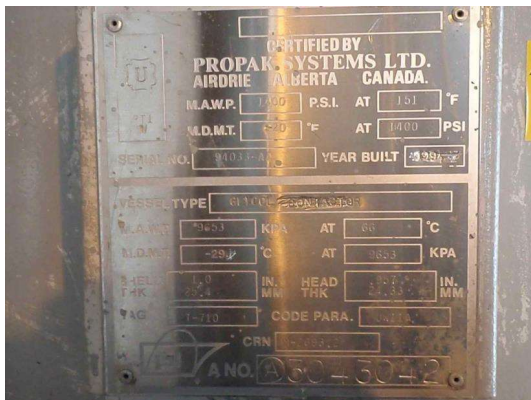
Figure: 3

Vessel Nameplate General Overview

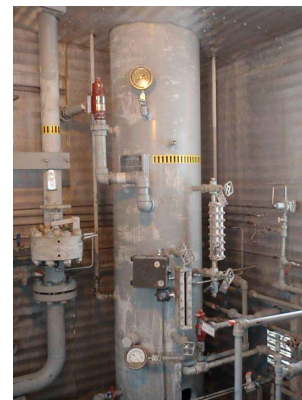
Figure: 4

Bottom of Vessel General Overview

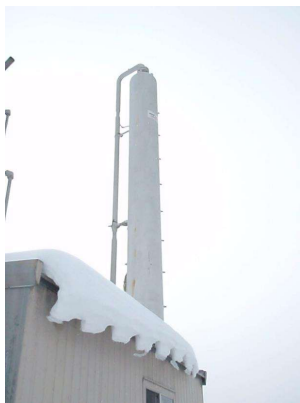
Figure: 5

Top of Vessel General Overview

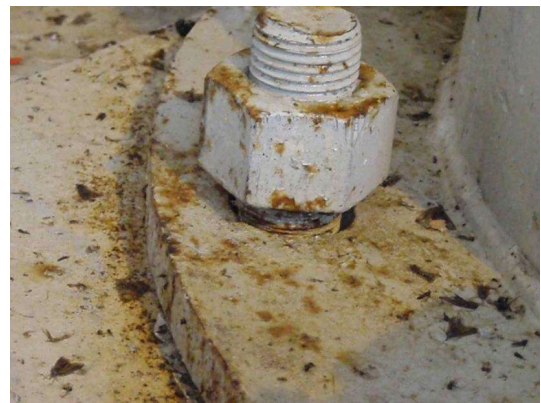
Figure: 6

Support Bolt not fastened.
