**Canadian Natural Resources Limited
PRESSURE VESSEL INSPECTION FORM**

District: Ft St. John, BC		Skid No. Flare Knock-Out				
Facility: Nig Creek Compressor Station		Location (LSD): a-43-A / 94-H-4				
Vessel Name & Equipment Number: Flare Knock-Out Drum						
Orientation: Horizontal						
Status: In Service		Regulatory Inspection				
PRESSURE VESSEL NAMEPLATE DATA						
"A" or "G" or "S" (Sask.) or BC Registration Number. A0570619		CRN Number T 9097.2				
Vessel serial number: C6-2611		Size: 48 in x 10 ft				
Shell thickness: 9.5 mm		Shell material: SA 516 70				
Head thickness: 7.9 mm		Head material: SA 516 70				
Tube wall thickness:		Tube material:				
Tube diameter:		Tube length:				
Channel thickness:		Channel material:				
MAWP	Shell: 50 PSI	Operating pressure	Shell:			
	Tubes:		Tubes:			
Design Temp.	Shell: 100 °F	Operating temperature	Shell:			
	Tubes:		Tubes:			
X-ray: RT-2		Heat treatment: Nil				
Code parameters: ASME VIII DIV I		Joint efficiency (if on nameplate):

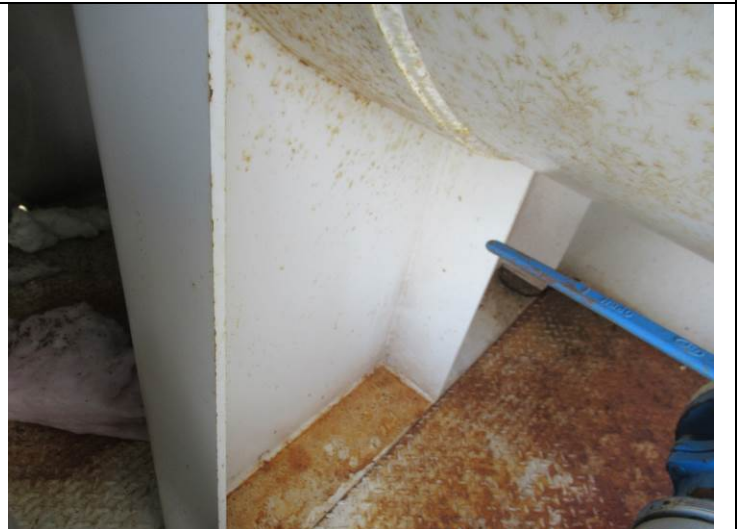
Anchor Bolts: Hammer tap to ensure secure. Look for corrosion, cracking in threads or signs of deformation.				X	Saddle is welded to skid deck.
Concrete foundation Check for cracks, spalling, etc.				X	
Ladder / Platform Describe general condition, ensure support is secure to vessel, describe any hazards.				X	
Nozzle: Assess paint, look for leakage, and ensure stud threads are fully engaged. Record any damage, deflection, etc. Are nozzles gusseted? Inspect gussets for cracking.	X				Paint in good condition – no exposed metal Studs are fully engaged to nuts – no short bolts. No damage or deflections Nozzles are not gusseted
Gauges: Ensure gauges are visible, working, no leakage, and suitable for range of MAWP/ Temp.	X				Liquid level gauge attached - clean and clear – no leaks
External Piping: Ensure pipe is well supported. All clamps, supports, shoes, etc. in place. Look for evidence of structural overload, deflection, etc. Paint condition, external corrosion?	X				Paint in good condition – no exposed metal Piping is well supported- all clamps and supports are in place. No structural overloads or deflections
