**Canadian Natural Resources Limited
GENERAL PRESSURE VESSEL INFORMATION**

**4016382
Job 4016101**

District: Fort St. John, BC	Skid No.
Facility: Pee Jay Unit 3 – Nancy Battery	Location (LSD): d-65-H / 94-A-15
Vessel Name Equipment Number: Free Water Knockout Drum	
Orientation: Horizontal	
Status: In Service	Regulatory Inspection

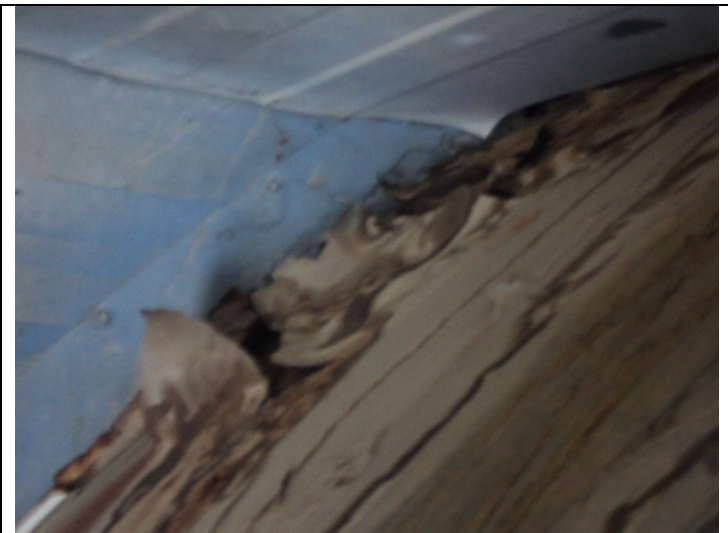
Paint peeling at 12 O'clock

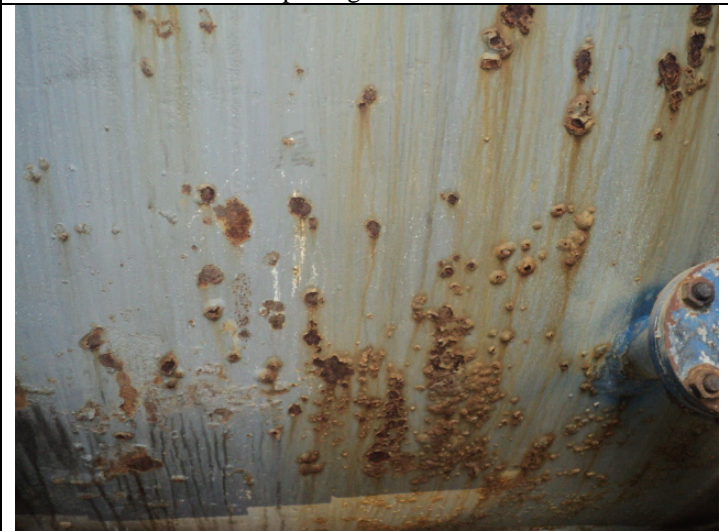
Spotting external corrosion on shell

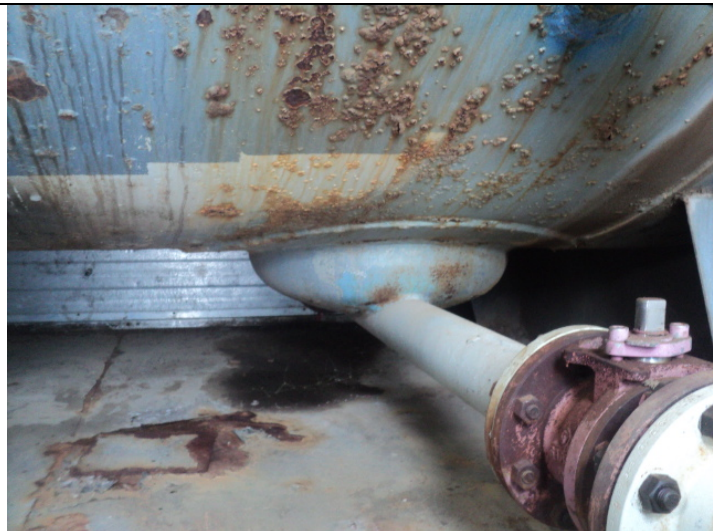
Spotting external corrosion on lower shell and boot

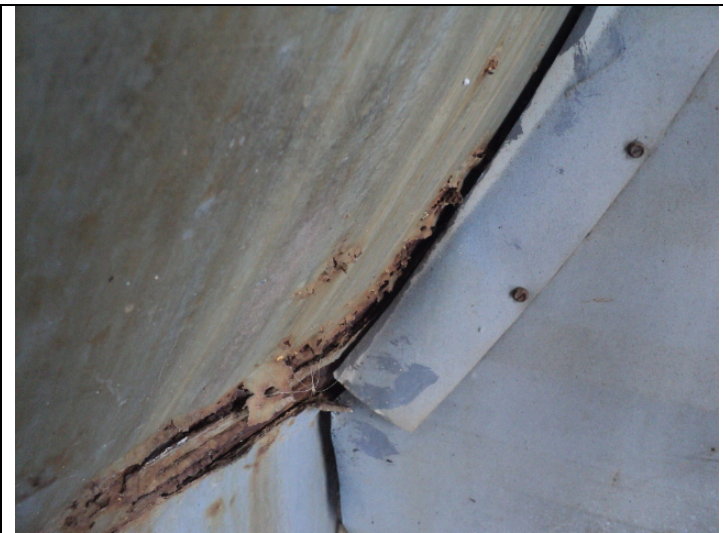
External Inspection Items	G	F	P	N/A	Comments
Insulation Verify sealed around manways, nozzles, no damage present, and there is no egress of moisture.		X			Cladding in fair overall condition – no open or torn sections- minor exposed insulation on the north head due to missing sealant – minor evidence of egress of moisture at 12 O'clock from openings in the roof – currently no wet insulation.
External Condition Assess paint condition, areas peeling, record any corrosion, damage, etc (record location, size and depth of corrosion or damage)		X			Paint in fair condition – minor flaking and peeling to approximately 10% of shell surface, concentrated at 12 O'clock position - scattered areas of surface corrosion – pitting to 0.020 inch deep max.
Leakage Record any leakage at flanges, threaded joints, weep holes on repads, etc.		X			Product seeping at inlet flanged connection and threaded connection to liquid level controller.

General condition of north head seal

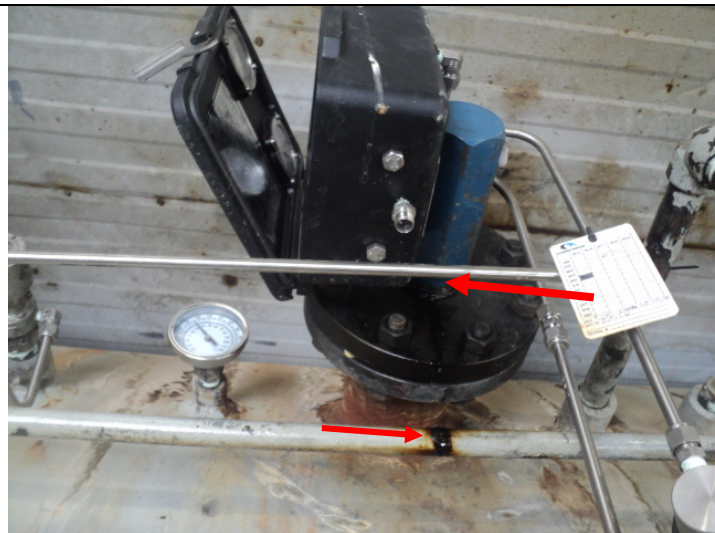
Liquid level gauge evidence of seepage at threaded connection

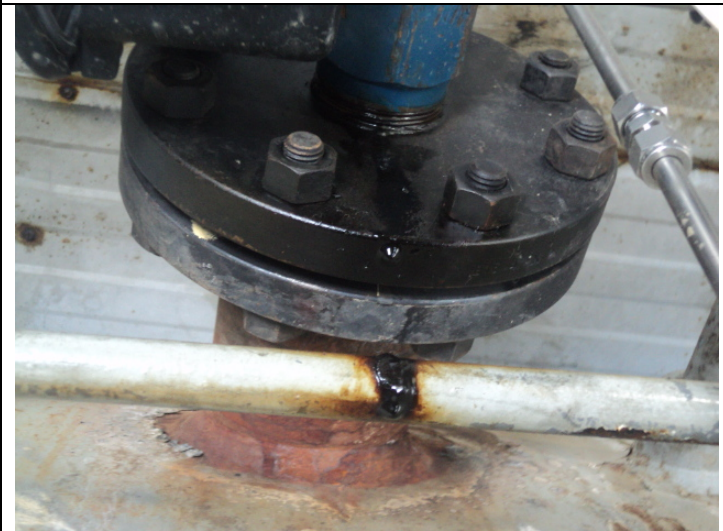
Macro of threaded connection

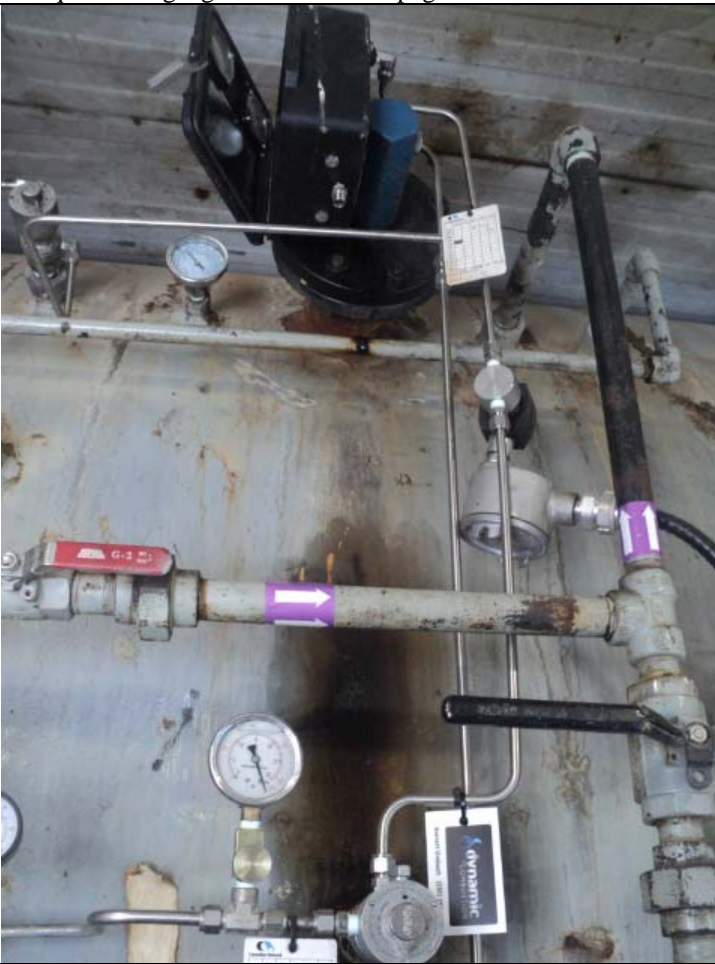
Evidence of external staining due to seepage

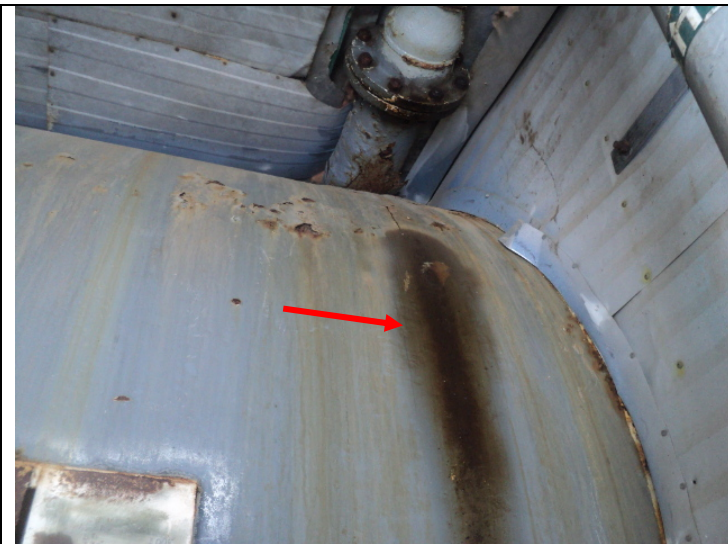
Evidence of external staining due to seepage

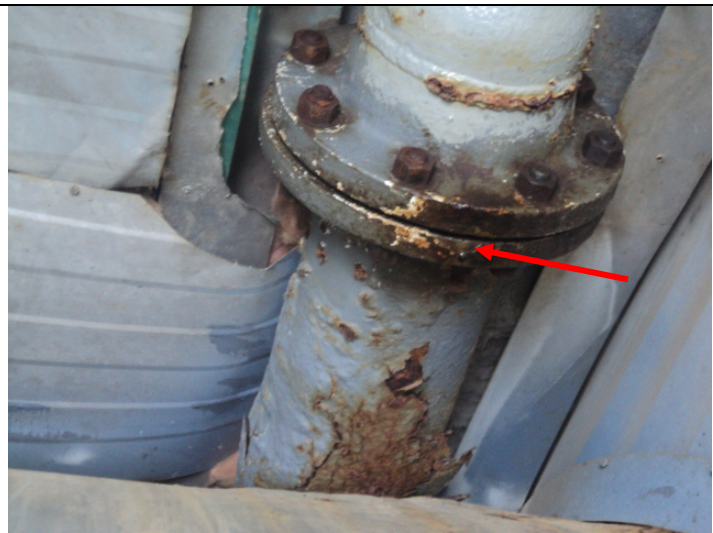
Macro of flanged connection

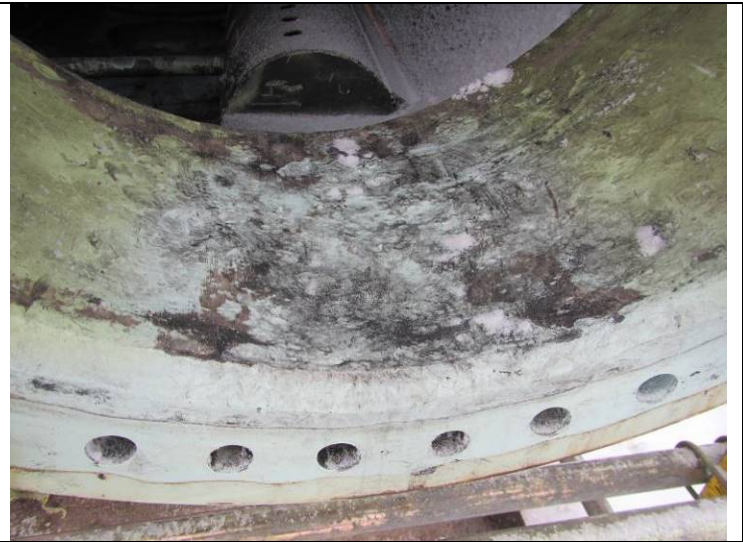
Previous corrosion on fire tube access

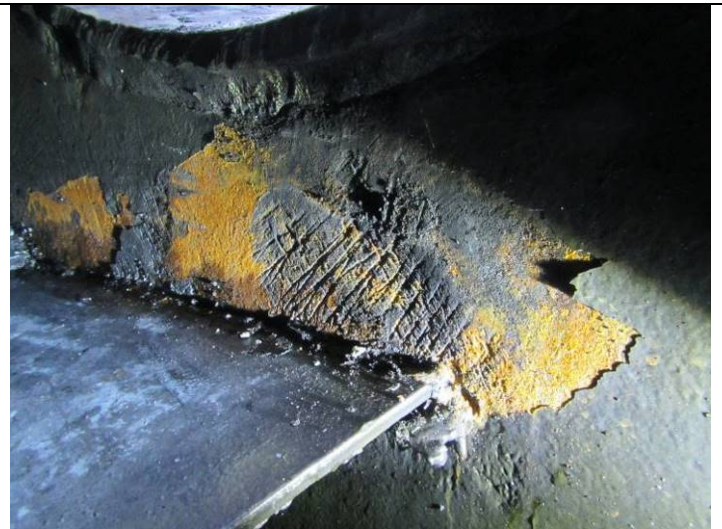
Coating damage on the north head – previous corrosion

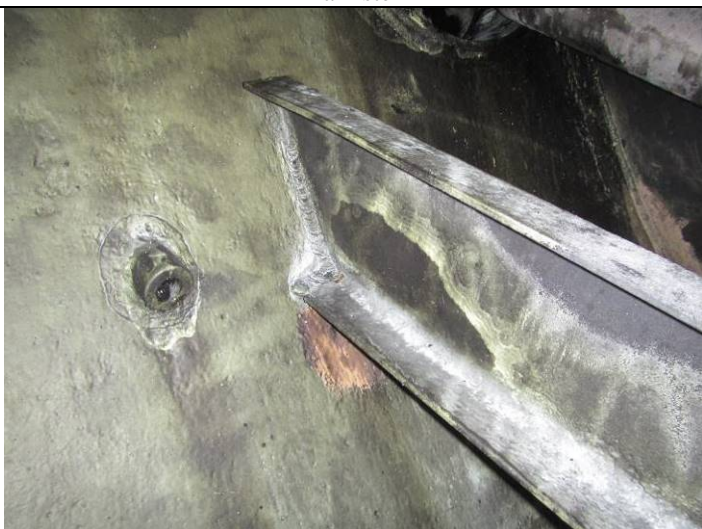
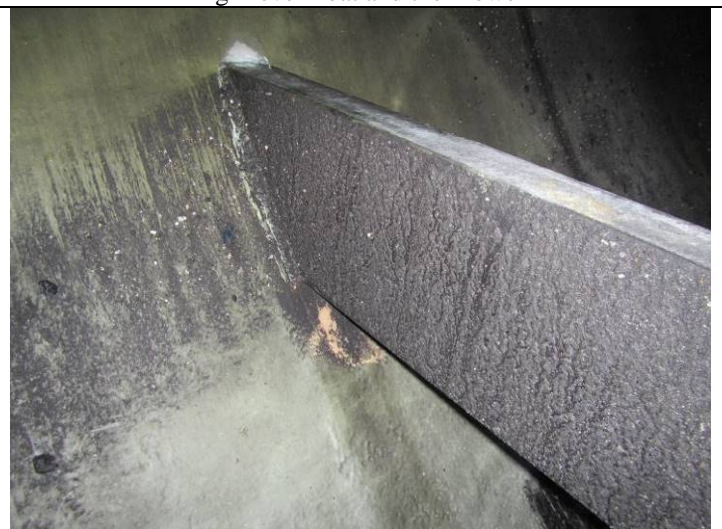
Fire tube supports welded to shell – no corrosion or damaged coating

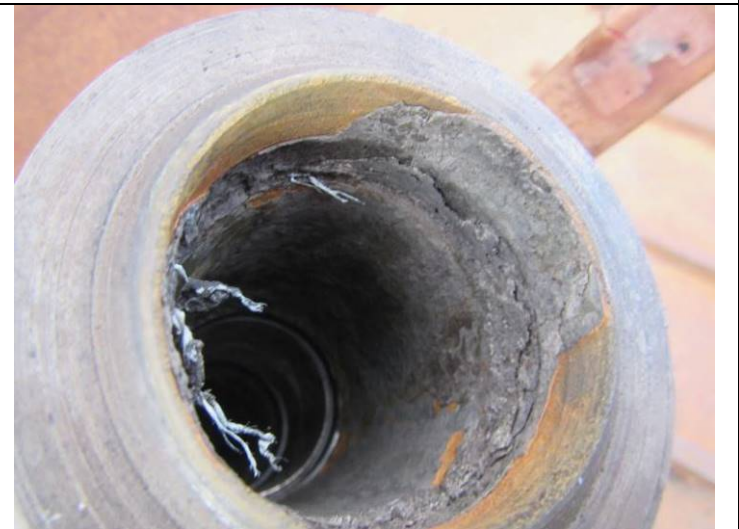
Corrosion on 2 inch threaded piping off gas boot

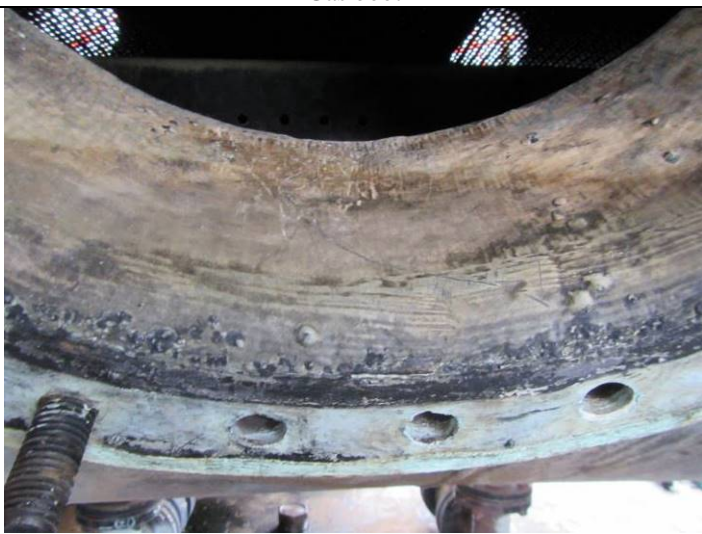
Small diameter coating blisters on manway

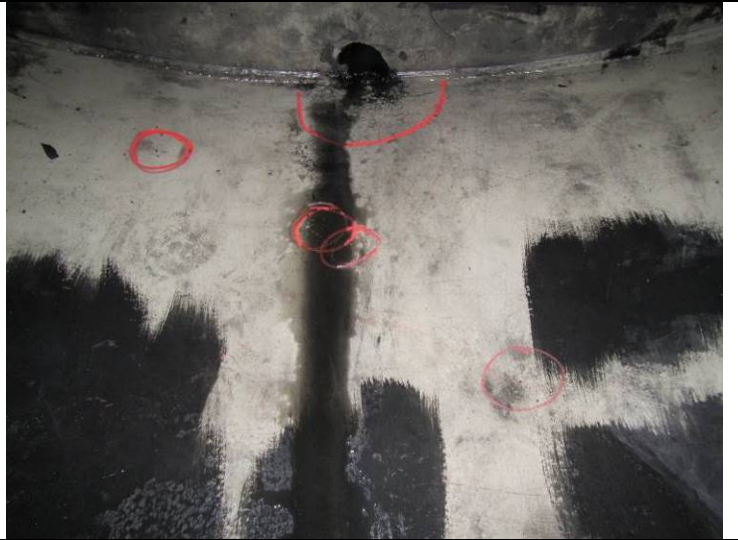
Coating damage at the north side of the back-end

Recommendations or corrective actions : Vessel is Fit for Service or describe corrective actions required)
(MIC to review corrective actions with Operations, discuss with Chief Inspector where necessary, and get remedial action implemented)
Recommendations: 1. Carry out coating repairs in back end 2. One roller for the fire tube support was found broken – repair and reinstall
Summary: Vessel is in overall good condition, visual external inspection and ultrasonic corrosion survey performed—shell metal thickness detected below nominal. New corrosion detected in the back end – one isolated pit on the bottom shell to 0.050 inch max depth.
Vessel is fit for service.

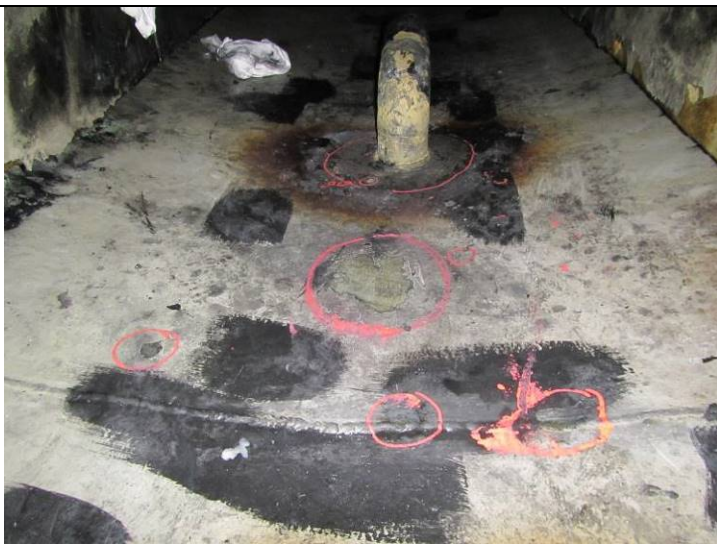
Overview of coating damage in back-end

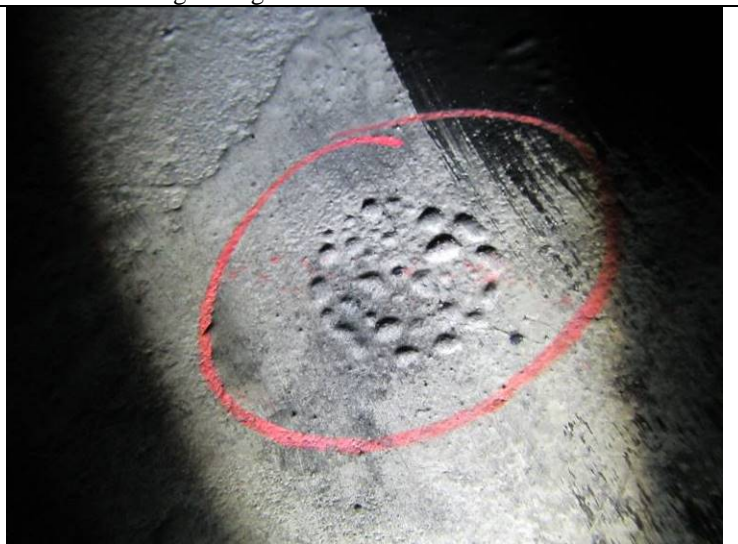
Small diameter blistering on bottom shell

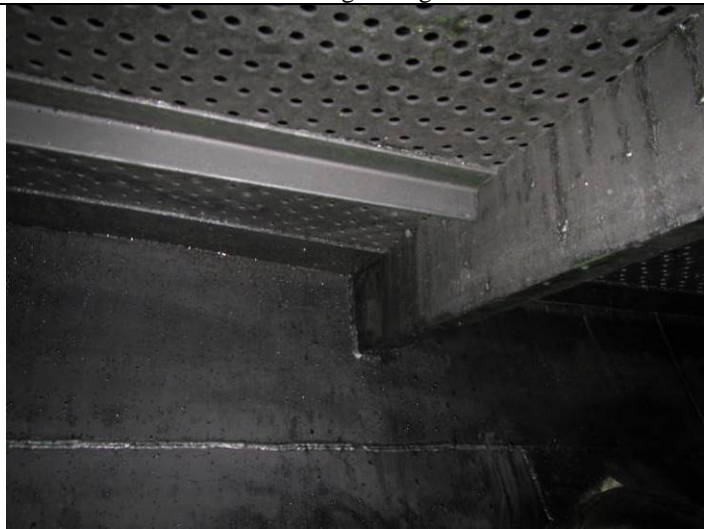
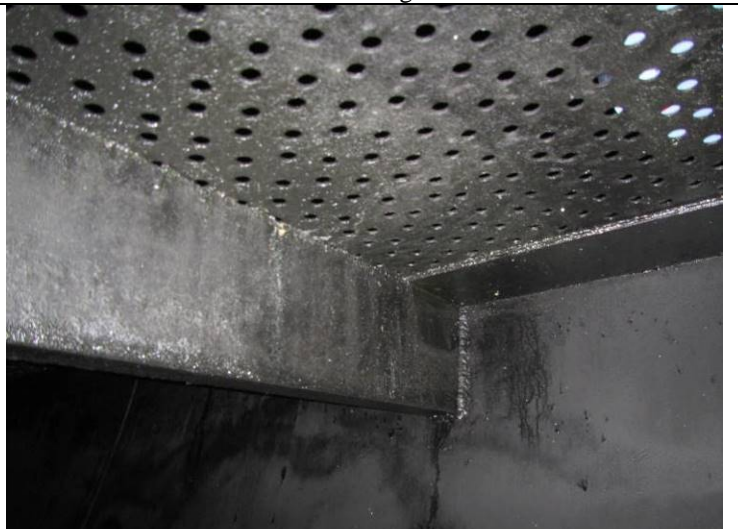
Screens supports are in good condition – no corrosion or mechanical damage noted

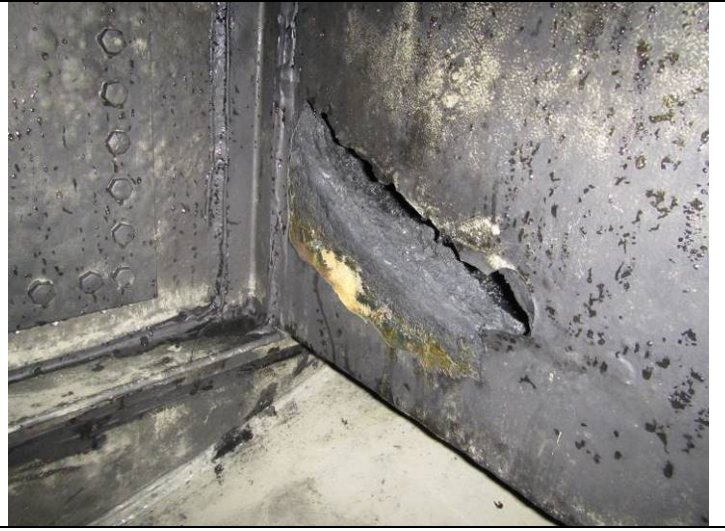
Back-end diffuser is corroded out
