**Canadian Natural Resources Limited  
GENERAL PRESSURE VESSEL INFORMATION**

**Job # 105.01652**

District: <b>Fort St John, B.C.</b>	Skid No.
Facility: <b>South Bulrush Compressor Station</b>	Location (LSD): <b>b-88-F / 94-A-16</b>
Vessel Name Equipment Number: <b>Inlet Separator</b>	
Orientation: <b>Vertical</b>	
Status: <b>In Service</b>	<b>Regulatory Inspection</b>

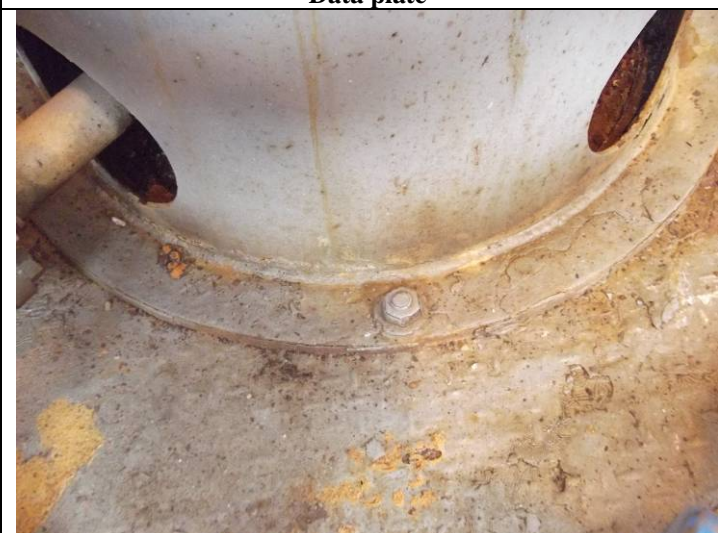
**Base anchored securely**

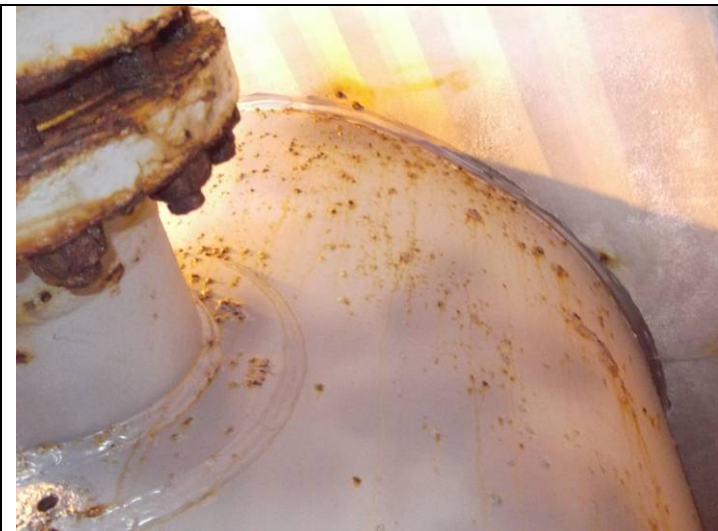
External corrosion

<b>Recommendations or corrective actions :</b> Vessel is Fit for Service or describe corrective actions required) (MIC to review corrective actions with Operations, discuss with Chief Inspector where necessary, and get remedial action implemented) <b>Recommendations: 1. Grit blast and repaint the vessel &amp; all of the corroded inlet &amp; outlet piping.</b> <b>Summary:</b> This vessel is in good over all condition, visual external and ultrasonic thickness survey carried out-pipe metal thickness detected below nominal minus corrosion allowance. Thickness calculations carried out to ensure sufficient metal exists. Long term corrosion rate based on greatest thickness loss (head) 0.125mm per year. Retirement Date to “T”min is year 2074.  <b>Vessel is fit for service.</b>

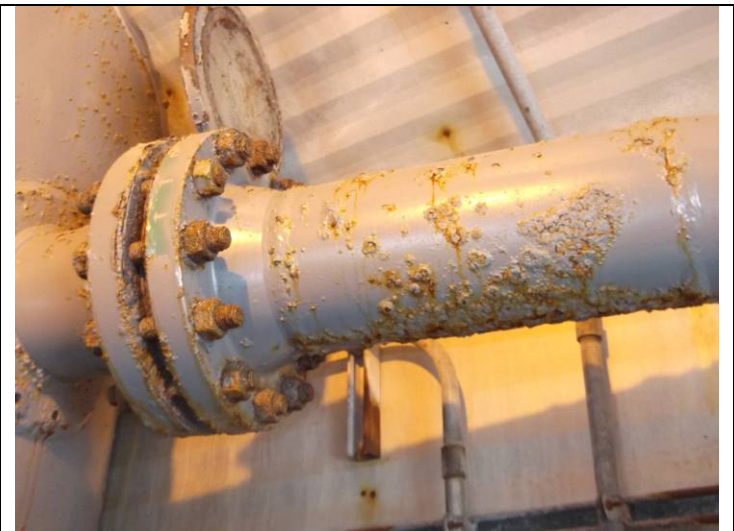
External corrosion
